Manhole Inspection Summary

Manhole # S31KK1003MH

Location Address: **109 OVERHILL RD**

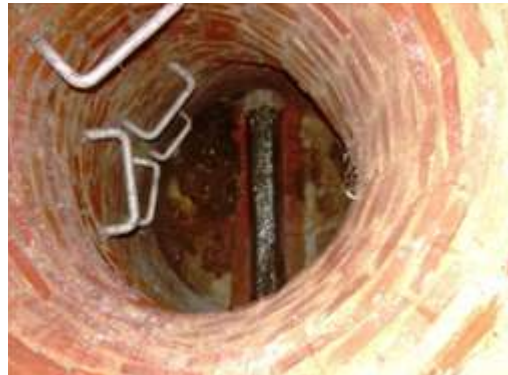
Top View

Barrel infiltration. Evidence of surcharge - Bench debris.

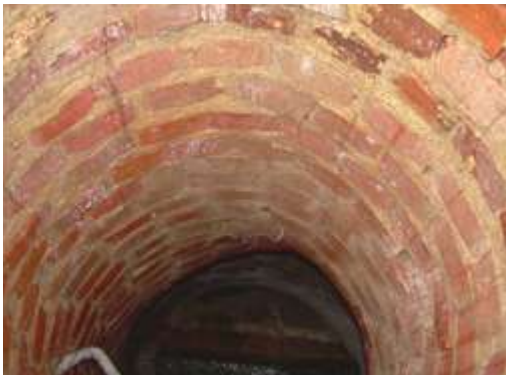
Defect

Adjustment deterioration and infiltration.
Corbel root intrusion and infiltration.

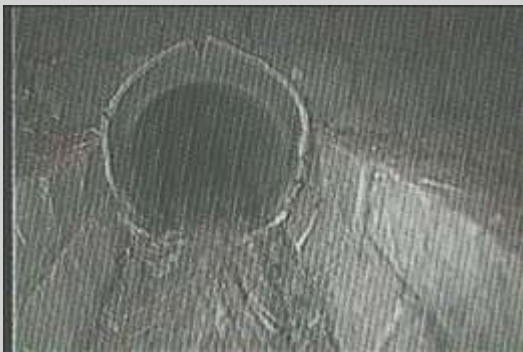
8 in. Circular Gravity Sewer Pipe Out @ 12 O'Clock

Barrel deterioration and infiltration. Channel deterioration.

Infiltration: **None** Pipe Seal Cond: **Cracked**

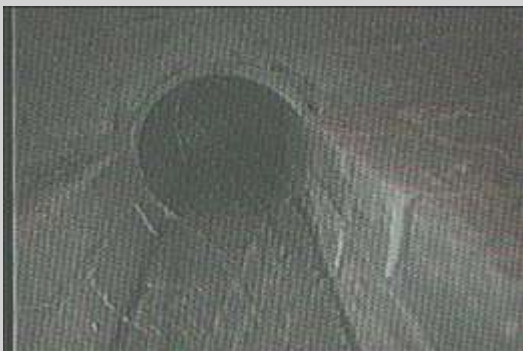
8 in. Circular Gravity Sewer Pipe In @ 6 O'Clock

Channel deterioration.
